HISTORIC SITES AND MONUMENTS BOARD OF CANADA

RAILWAY STATION REPORT

Title: Canadian National Railways Station
Glencoe, Ontario

RSR-268

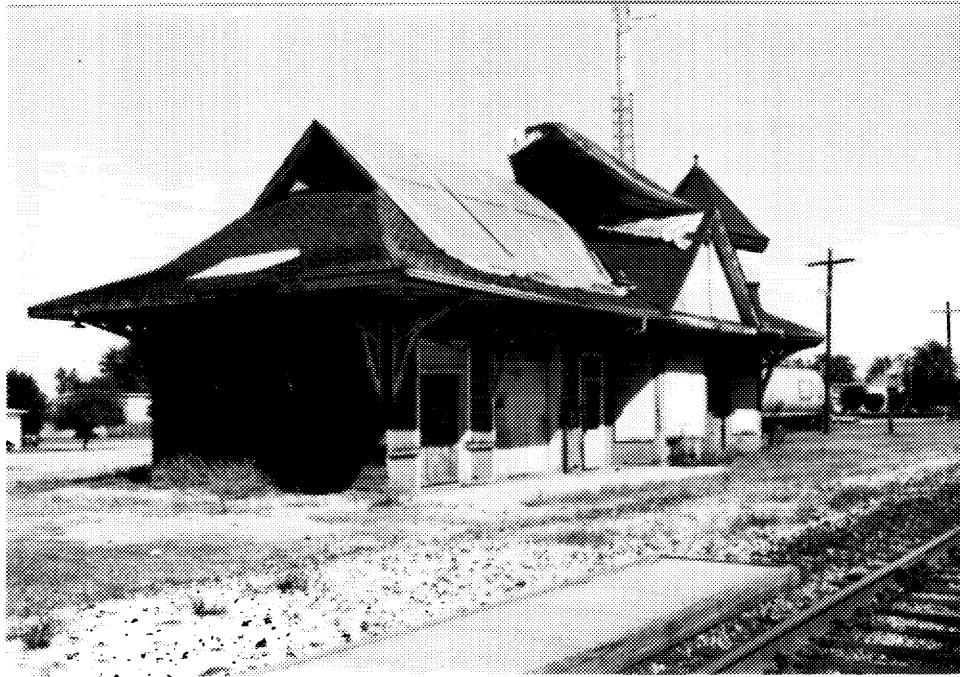
6 Glencoe station, west end from south. (A. M. de Fort-Menares, 1995.)

The gable of the roof ridge breaks the hip of the west end, and a small window is carried in the resulting typanum. The roof breaks pitch at the wall edge, so that the eaves are carried out at a flatter angle (Figure 6). On each of the north (townside) and south (trackside) elevations, gables on the axis of the operator's bay feature shingled planes that slice above, and curve in to, deep-set sash windows, a device popular in Queen Anne Revival domestic treatments (Figure 7). Finally, an octagonal tower set into the east end was carried down to define the glazed, pavilion-like space of the ladies' waiting room (Figure 8). This tower, with a medium height cap, was glazed above the drum with 15-light, apparently fixed windows set horizontally. Fenestration on ground floor passenger area windows featured eight small panes as a transom above large one-over-one sash; fenestration in the working spaces appears from photographs to have had multi-paned sash, or cages over single lights, for practical purposes (Figure 9).

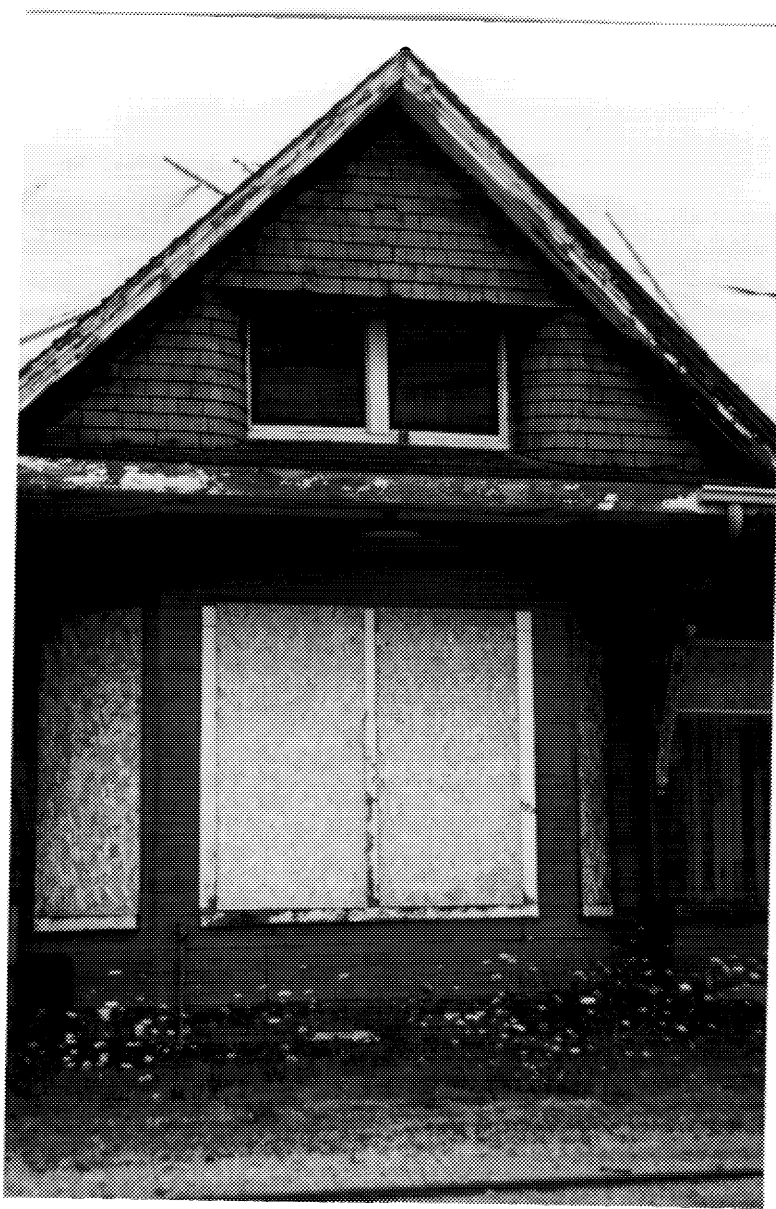
7 Glencoe station, Queen Anne Revival gable on north. (A. M. de Fort-Menares, 1995.)

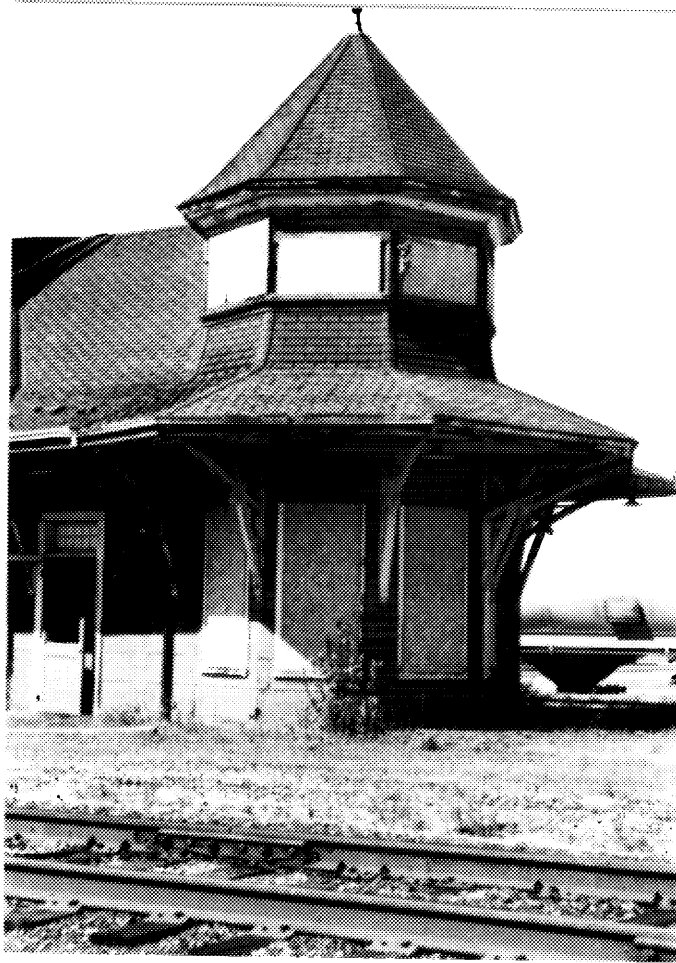
8 Glencoe station, tower on east end with boarded windows.
(A. M. de Fort-Menares, 1995.)

The station has suffered somewhat from neglect and closure, although many of the visual defects are actually protective measures. General maintenance of the site stopped when the building went out of public service. All the windows are now boarded up, as is the trackside gable. The wood shingles and metal ridge rolls of the roof have long since been replaced, and the roof is temporarily draped in battened plastic to mitigate leaks. Decades ago the frame materials were covered in composite shingle sheeting, which is now brittle and breaking (Figure 13). Exposed wood members, such as the struts, badly need painting, and deterioration of the roof has caused rotting of the soffits.

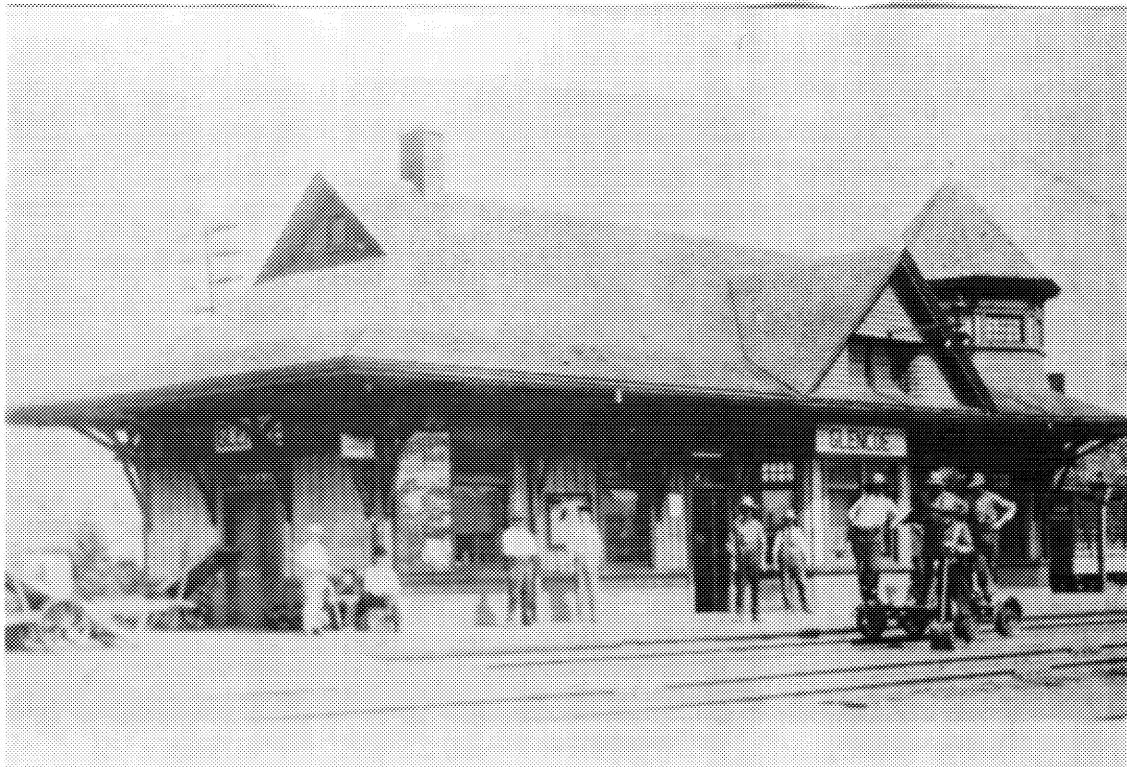
9 Glencoe station, historic photograph of south elevation with wall poster from 1911. (Glencoe & District Historical Society.)

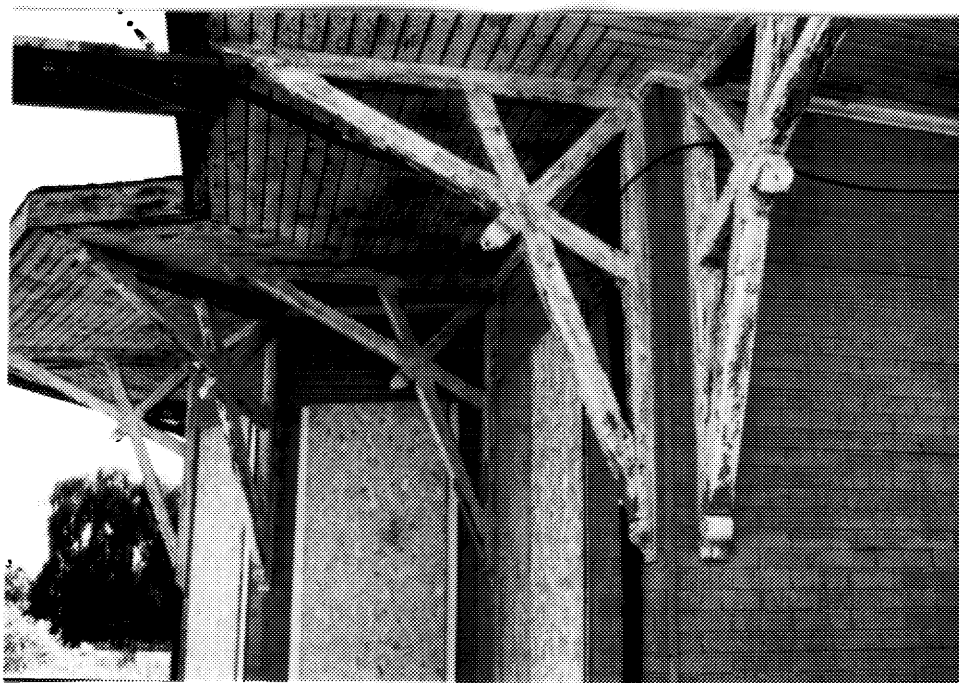
10 Glencoe station, detail of brackets, east end. (A. M. de Fort-Menares, 1995.)

The walls were divided into the usual three horizontal registers, with board and batten cladding on the register occupied by the windows. The ornamental brackets were exceptionally prominent, comprising X forms bending in toward a centre strut, whose profile gave the building a cage-like quality in silhouette (Figure 10). The operator's bay was reflected on the townside by an identical projection, an unusual elaboration that accommodated the need for train control on both sides of the station (Figure 11).

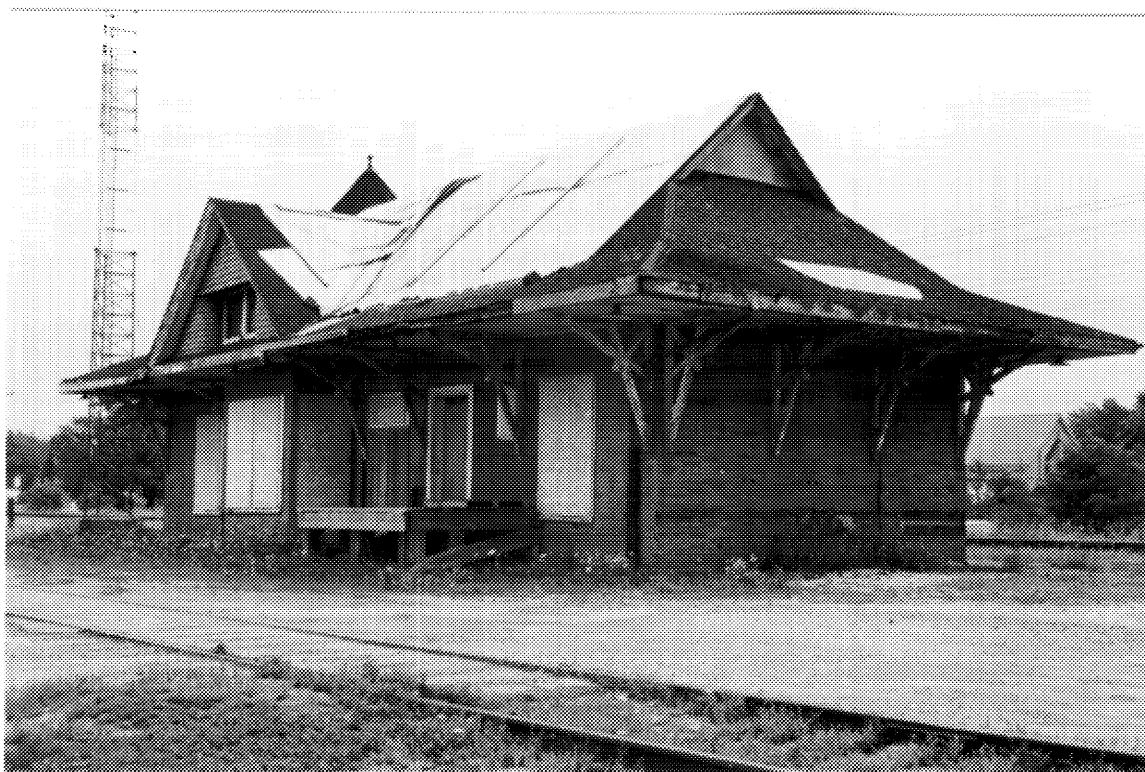
11 Glencoe station, north townside. (A. M. de Fort-Menares, 1995.)

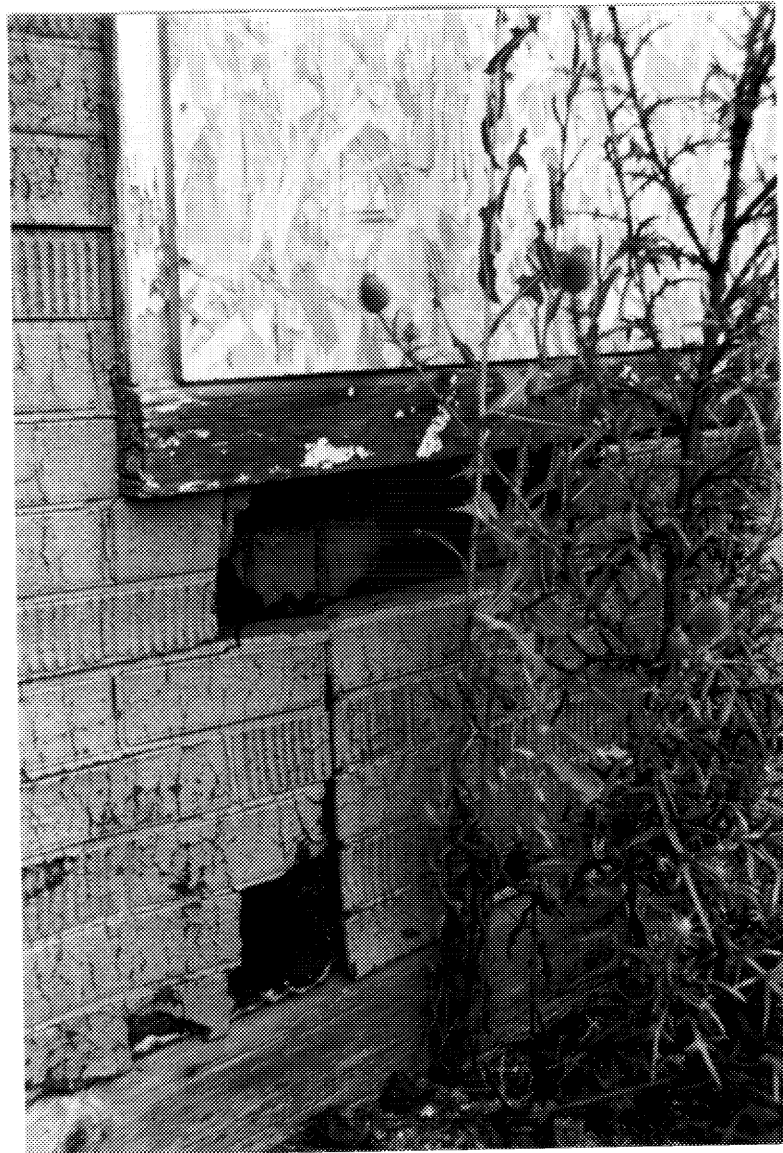
13 Disintegrating sheet shingle material and overgrown weeds on south track front of Glencoe station. (A. M. de Fort-Menares, 1995.)

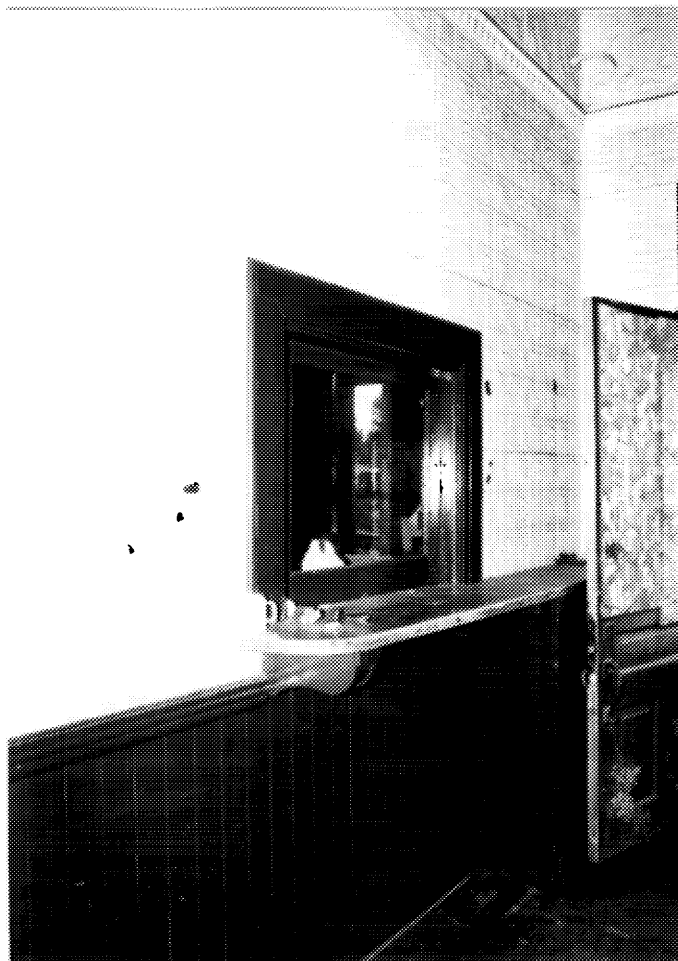
15 Ticket wicket in general waiting room, Glencoe station.
(A. M. de Fort-Menares, 1995.)

The plan was simple but elegant. Four separate spaces, each with their own access and through axes, fronted on both sides of the station. From east to west, these were the ladies' waiting room, the agents office, the mens' and general waiting room, and the baggage/freight room. Ticket wickets have large glass casements opening onto counters carried on console brackets (Figure 15).

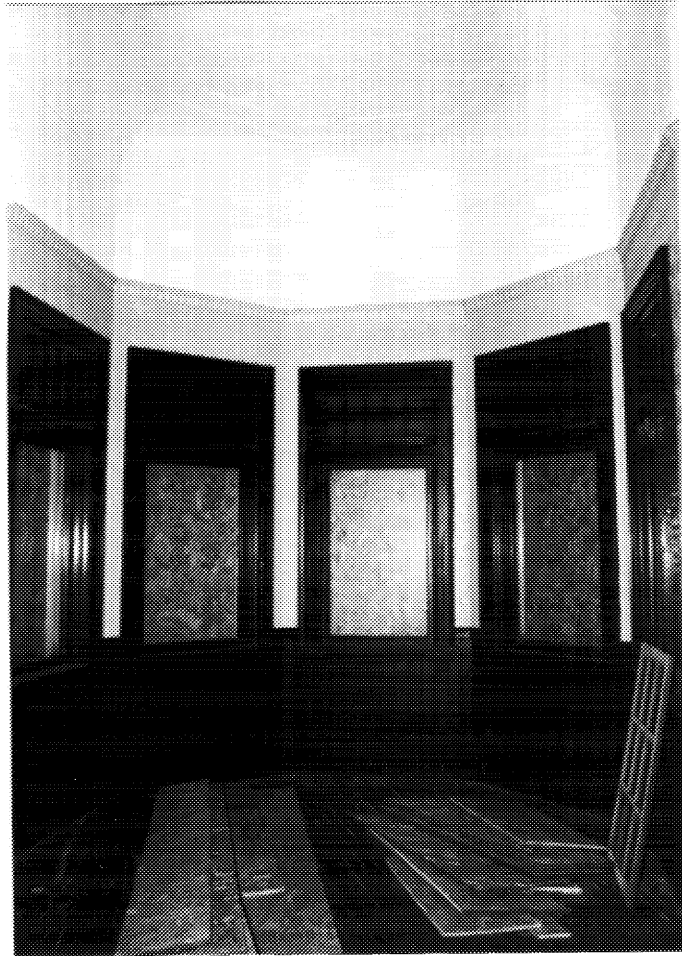
16 Ladies' polygonal waiting room looking east, Glencoe station. (A. M. de Fort-Menares, 1995.)

17 North entry wall and east wall in vestibule area of ladies' polygonal waiting room, Glencoe station. (A. M. de Fort-Menares, 1995.)

The irregular space of the ladies' waiting room joined a small rectangular space, almost an open vestibule, onto the polygon under the tower (Figures 16-17). This room probably had doors on both north and south, but only the south door is still in place. The north opening is a window.

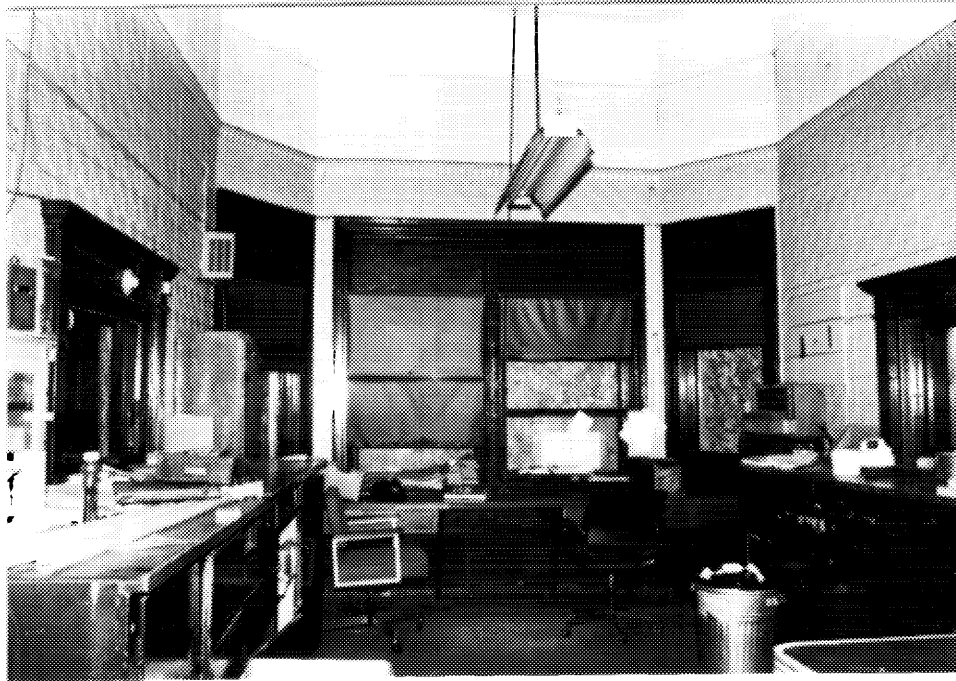
18 South bay of agents' office, Glencoe station. (A. M. de Fort-Menares, 1995.)

19 North bay of agents' office, Glencoe station. (A. M. de Fort-Menares, 1995.)

The agents' office is a generous open room with built-in counters, cabinets and shelving from various periods (Figures 18-19). The only access was from the general waiting room, although both waiting rooms had ticket counters, on offset axes. A quantity of telegraph equipment survives in place, plus a freestanding cast iron safe, and what may be an early counter dividing the room on the north end.

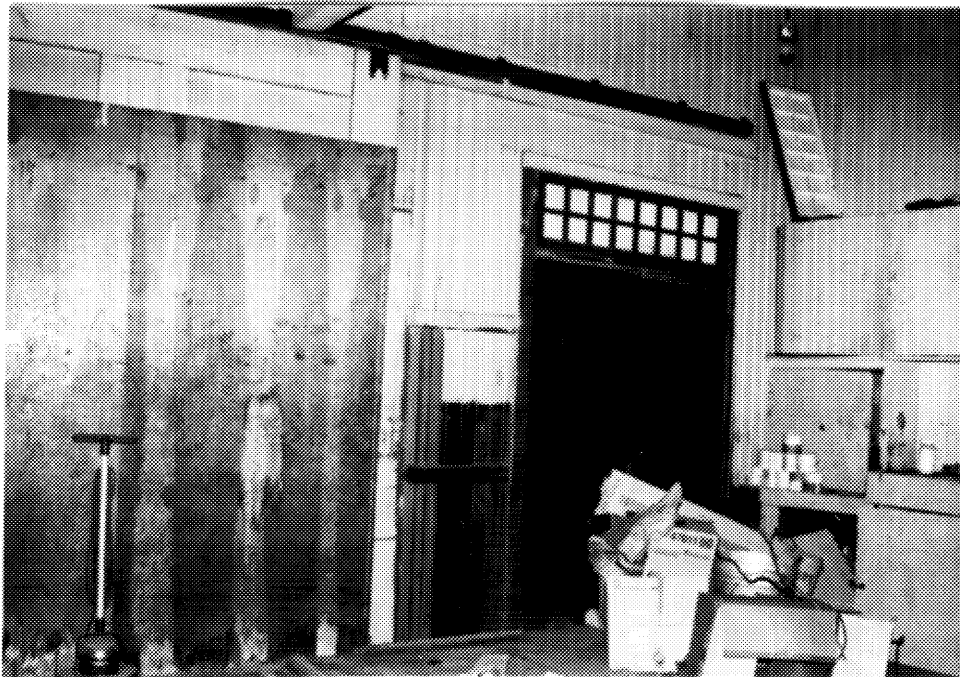
20 South wall of baggage room with new door opening on the left, original paired baggage doors on right. (A. M. de Fort-Menares, 1995.)

The former baggage room has been altered the most: its west door closed, windows turned in to freight doors, and new, elevated door openings with exterior loading docks installed (Figure 20). The room was enlarged to take in the whole former general waiting room. The wall between baggage and the general waiting room was torn down, the floor raised, and a new partition built to create an entry corridor between the agents' office and the enlarged freight room. The ceiling cove of the original spatial configuration has been left, however, so it is easy to see the dimensions of the waiting room (Figure 21).

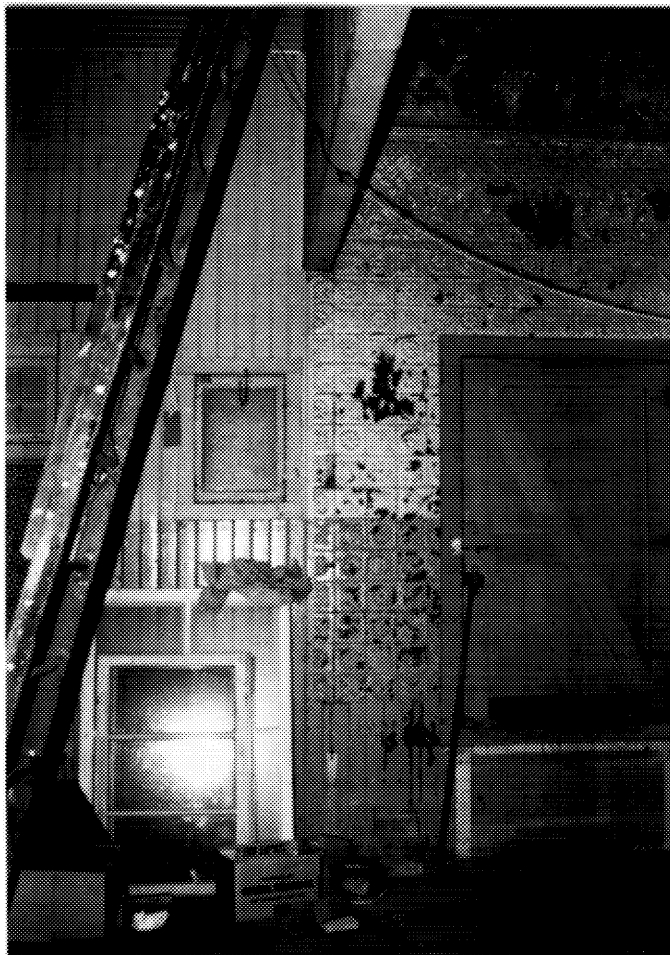
- 21 Interior of baggage room combined with former general waiting room, north wall, Glencoe station. The ladder on the left leans against remnants of the partition between the two rooms. The freight door on the right is an alteration. (A. M. de Fort-Menares, 1995.)
